National Dam Safety Program, Tomahawk  
Lake Dam (Inventory Number NY 618),  
Lower Hudson River Basin, Orange County,  
New York. Phase I Inspection Report.

PHASE I INSPECTION REPORT  
NATIONAL DAM SAFETY PROGRAM  
TOMAHAWK LAKE DAM  
I.D. No. NY 618  
DEC DAM No. 195A-2507  
LOWER HUDSON RIVER BASIN  
ORANGE COUNTY, NEW YORK

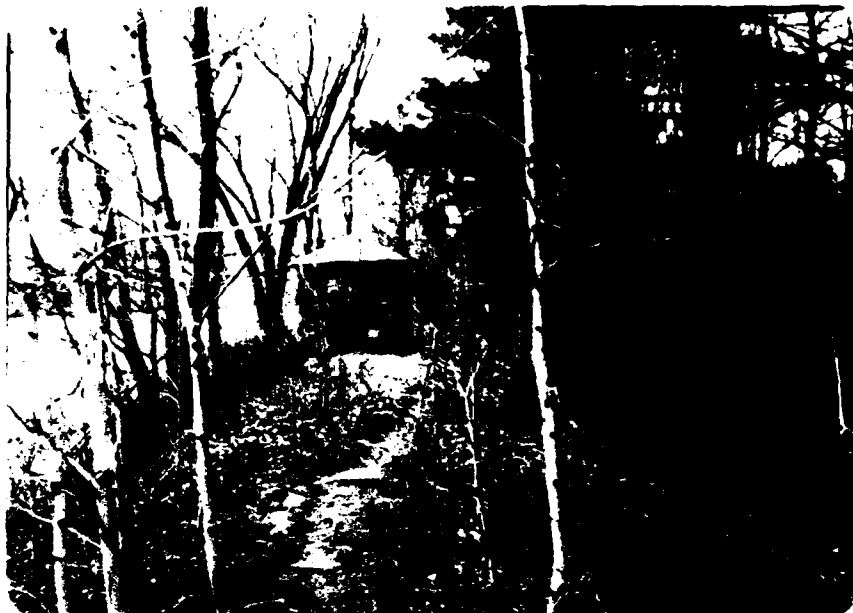
Photo 1. View of Crest, Downstream Slope, and  
Valve House on Right Side of Spillway  
9 March 1981
